Cultural Resource Survey
Property Identification Form

1. Name of Property: Ronald and Loretta Shackle Property (Tax Parcel # 1-34-12-143.00)
2. Street Location: 409 Atlantic Avenue (Route 26), east of Railway Road
3. Owner's Name: Ronald and Loretta Shackle Tel. #: _____
Address: 409 Atlantic Avenue, Millville, DE 19967
4. Type of Resource(s): building: ☒ structure: ☐ site: ☐
 object: ☐ district: ☐
5. Surroundings: (check more than one, if necessary)
- fallow field: ☒ cultivated field: ☐ woodland: ☒
 scattered buildings: ☒ structure: ☐ site: ☐
6. Function: original Residence present Residence
7. List Additional Forms Used:
- Main Building Form (CRS-2)
- Related Building Forms (2) (CRS-3)
- Continuation Sheets
8. Surveyor: Elizabeth Harvey/Katie Post Tel. #: (215) 592-4200
 Organization: McCormick, Taylor and Associates, Inc. Date: April 2002
 Address: 2001 Market Street, 10th Floor, Philadelphia, PA 19103

This resource was evaluated in association with the federally funded Route 26 Road Improvement Project initiated under Contract 99-112-01 in Fall 1998. The residence is located on Route 26 east of Railway Road. This I-House with Colonial Revival alterations was probably construc

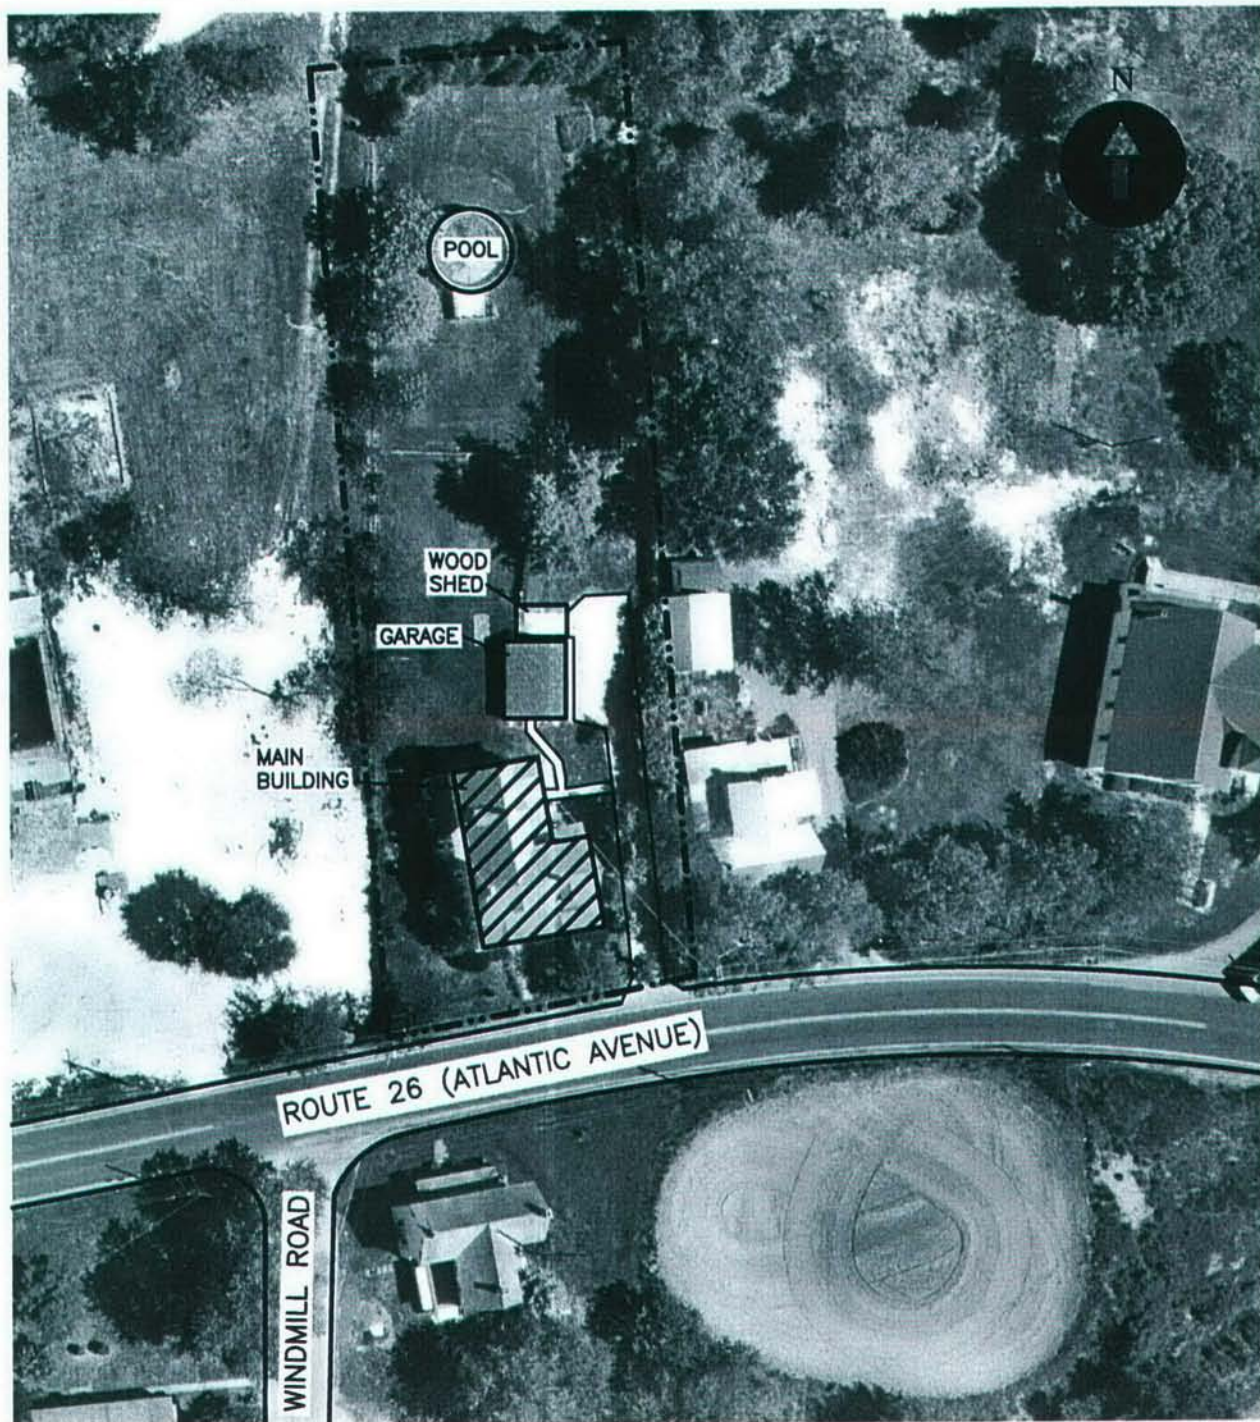
Sketch Plan:

To the rear of the main building is a contemporary, vinyl-clad, two-car garage with an asphalt-shingle gable roof. The garage doors are paneled metal.

To the rear of the main building and garage is a one-story, vinyl-clad wood shed.

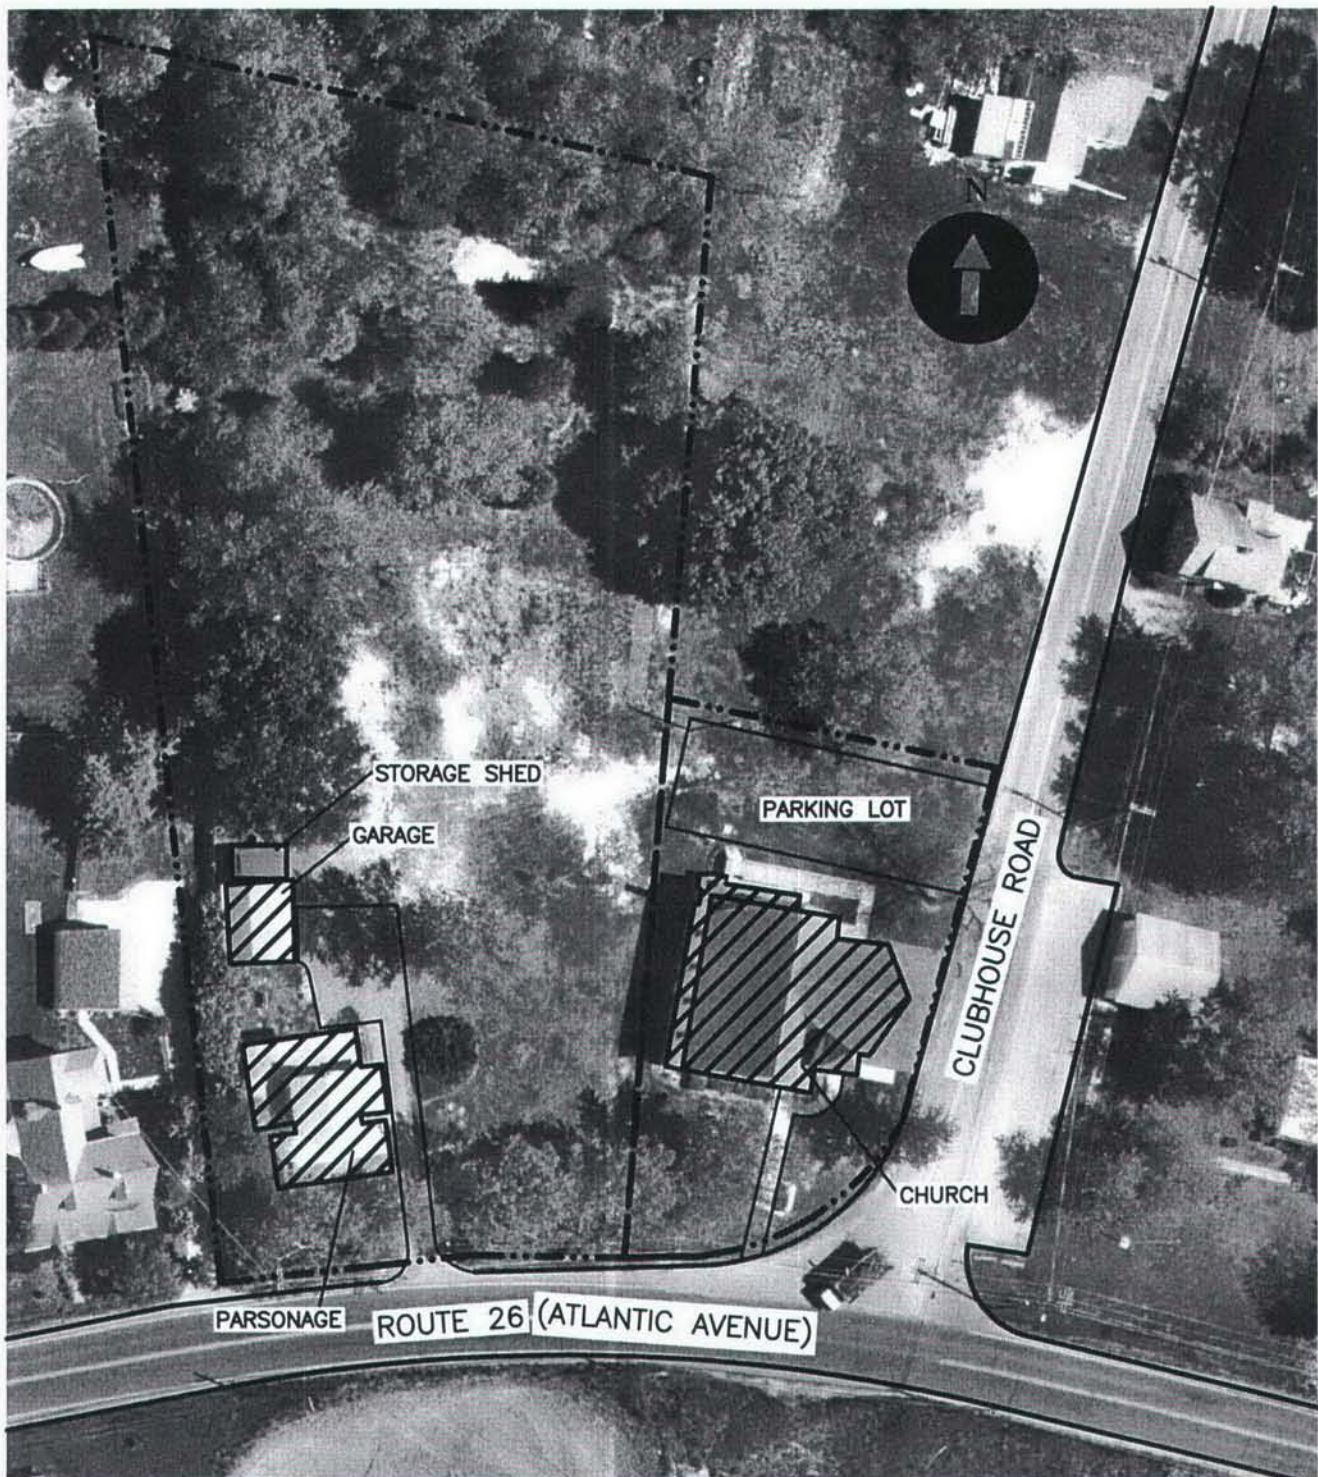
Sketch Plan:

The Parsonage is a two and one-half story, three-bay, vinyl-clad, I-house with an asphalt-shingle side-gable roof. The main (south) façade has an enclosed one-story entrance porch with an asphalt-shingle hipped roof and a central single-leaf entrance flanked by vinyl two-light awning windows. The second story has wood 1/1 windows. The east façade has wood 1/1 windows on the first and second floors and two single-light windows in the gable peak of the main block. Attached to the rear ell on this façade is a screened-in one-story porch with an asphalt-shingle gable roof. The rear façade has wood 1/1 windows, an exterior end brick chimney, and a one-story, weatherboard-clad addition with an asphalt-shingle gable roof.

To the north of the main building is a one and one-half story, two-bay, concrete-block garage with an asphalt-shingle gambrel roof. The main (east) façade has a single-bay vehicular entrance with a paired wood 8/8 window to its south. The south façade has a single-leaf pedestrian entrance with an aluminum door; to its west is a wood 1/1 window. The gable peak is clad in wood shake shingles and features a wood hay door.

To the north of the main building and garage is a prefabricated shed with a double-leaf entrance with wood board and batten doors and an asphalt-shingle gambrel roof.

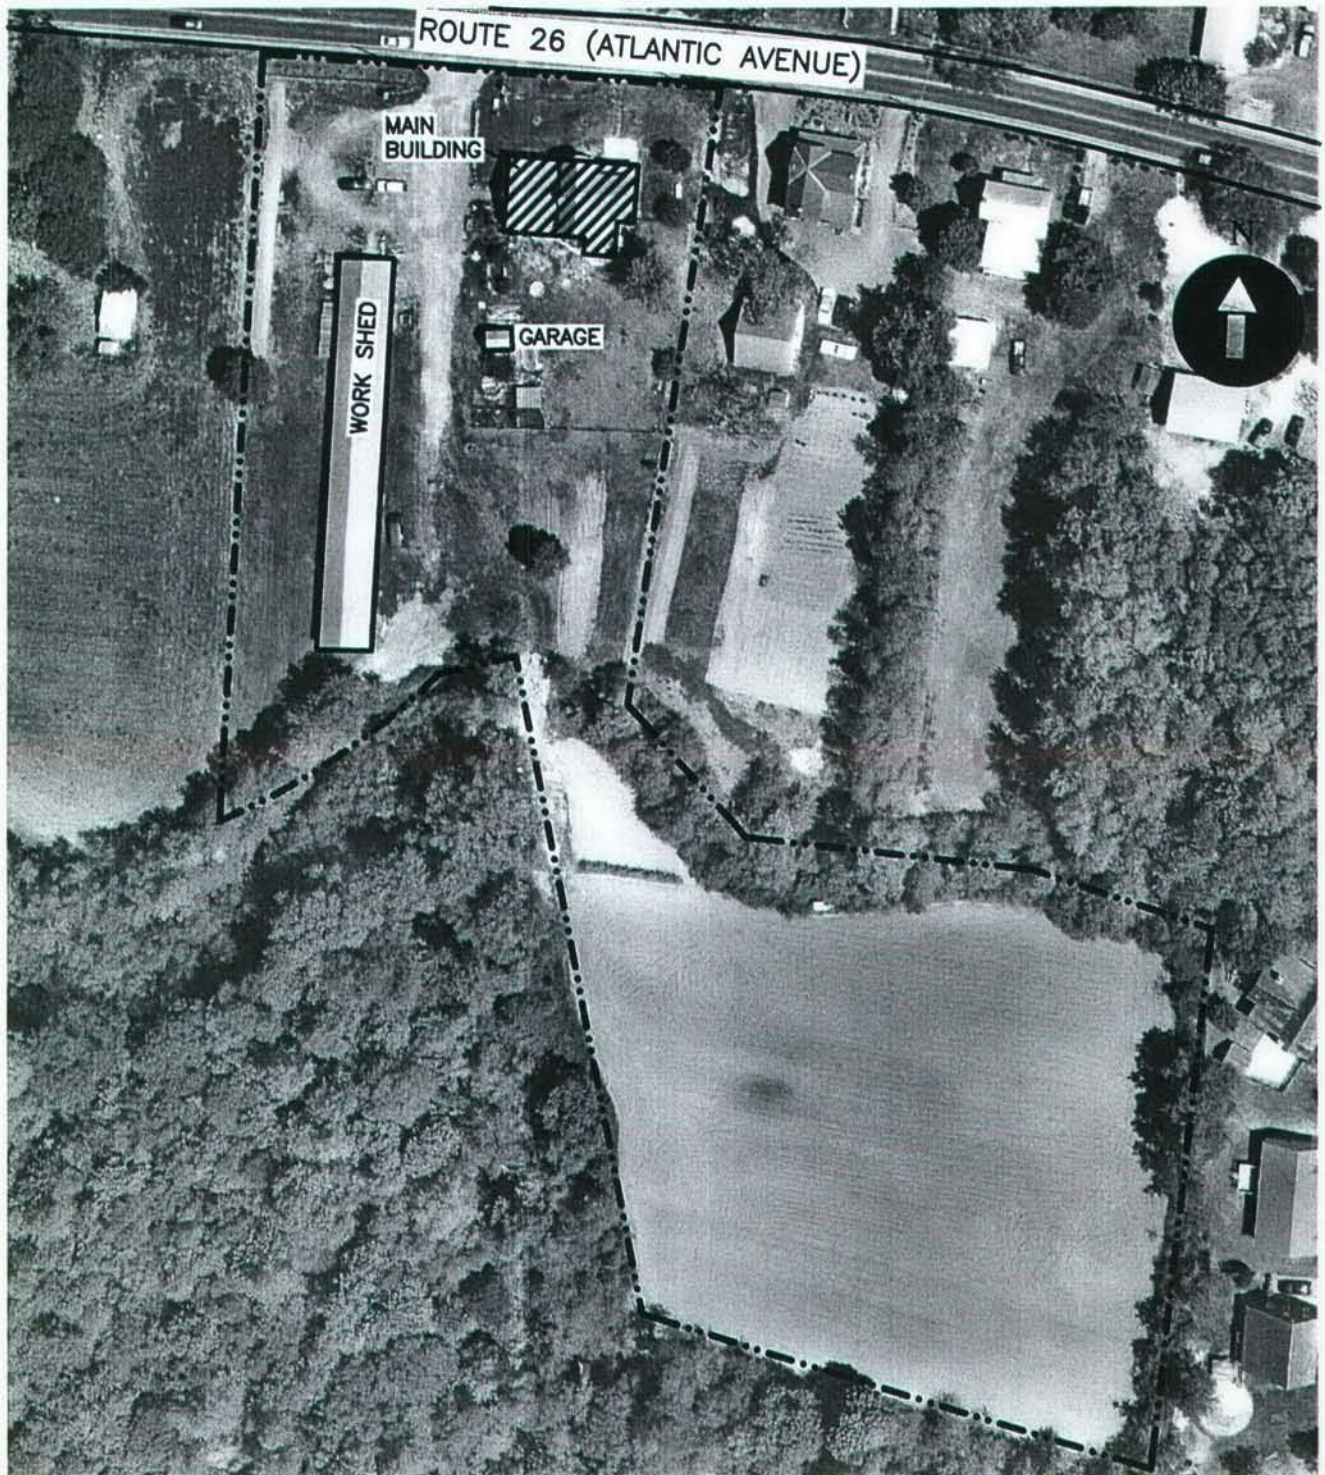
Sketch Plan:

While the location of the main building has been maintained, other attributes have been compromised. For example, the setting has been compromised by a contemporary garage and a contemporary alterations to a former chicken house adjacent to the main building; the feeling has been altered by increased commercial and residential development along Route 26; the association has shifted from use as a residence to use as a commercial/residential property; and the materials and workmanship have been compromised by vinyl siding, replacement windows and doors, a large one-story gable roof addition to the west, and a replacement porch on the main façade.
